San Jacinto River Waste Pits Superfund Site

USACE Support

San Jacinto River Waste Pits

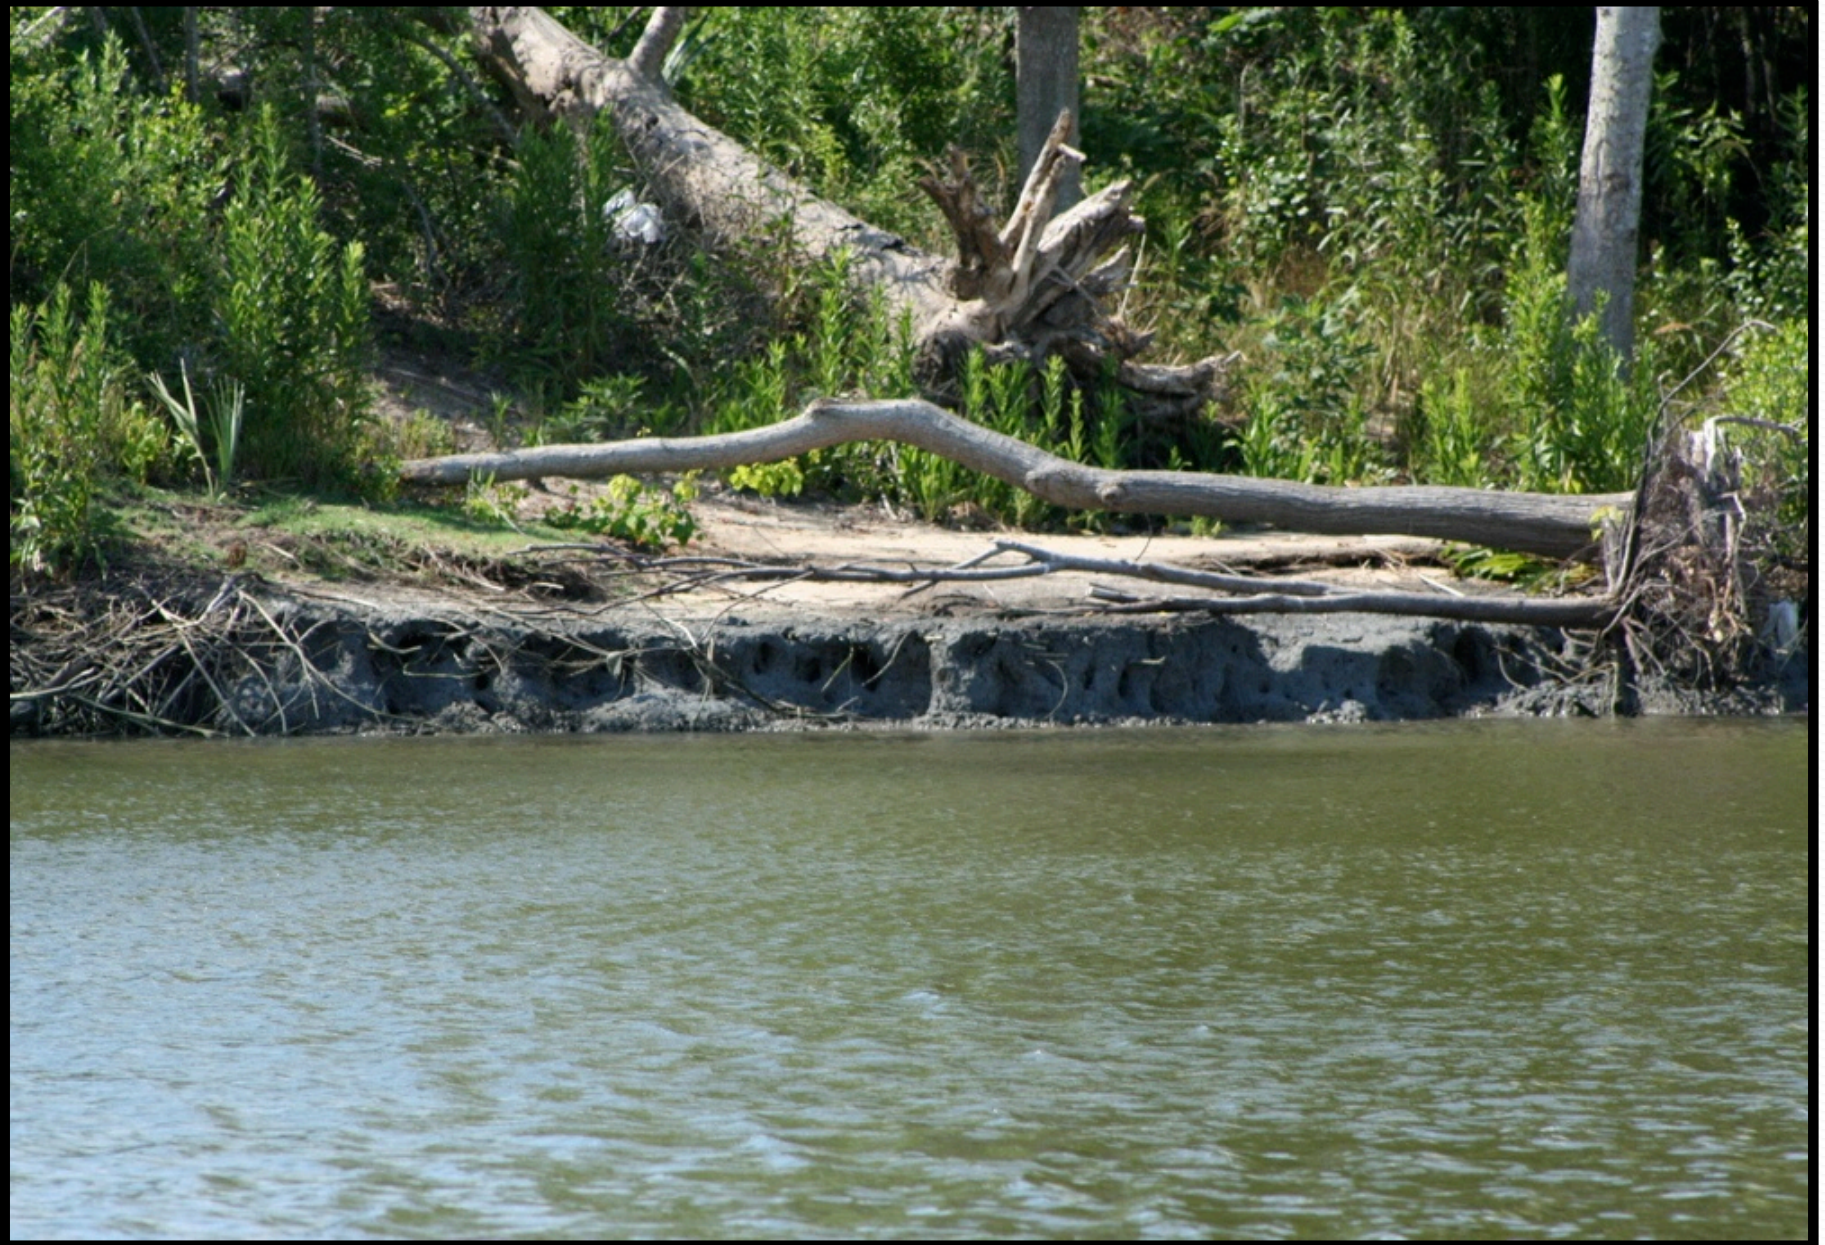
**South
Impoundment
1965**

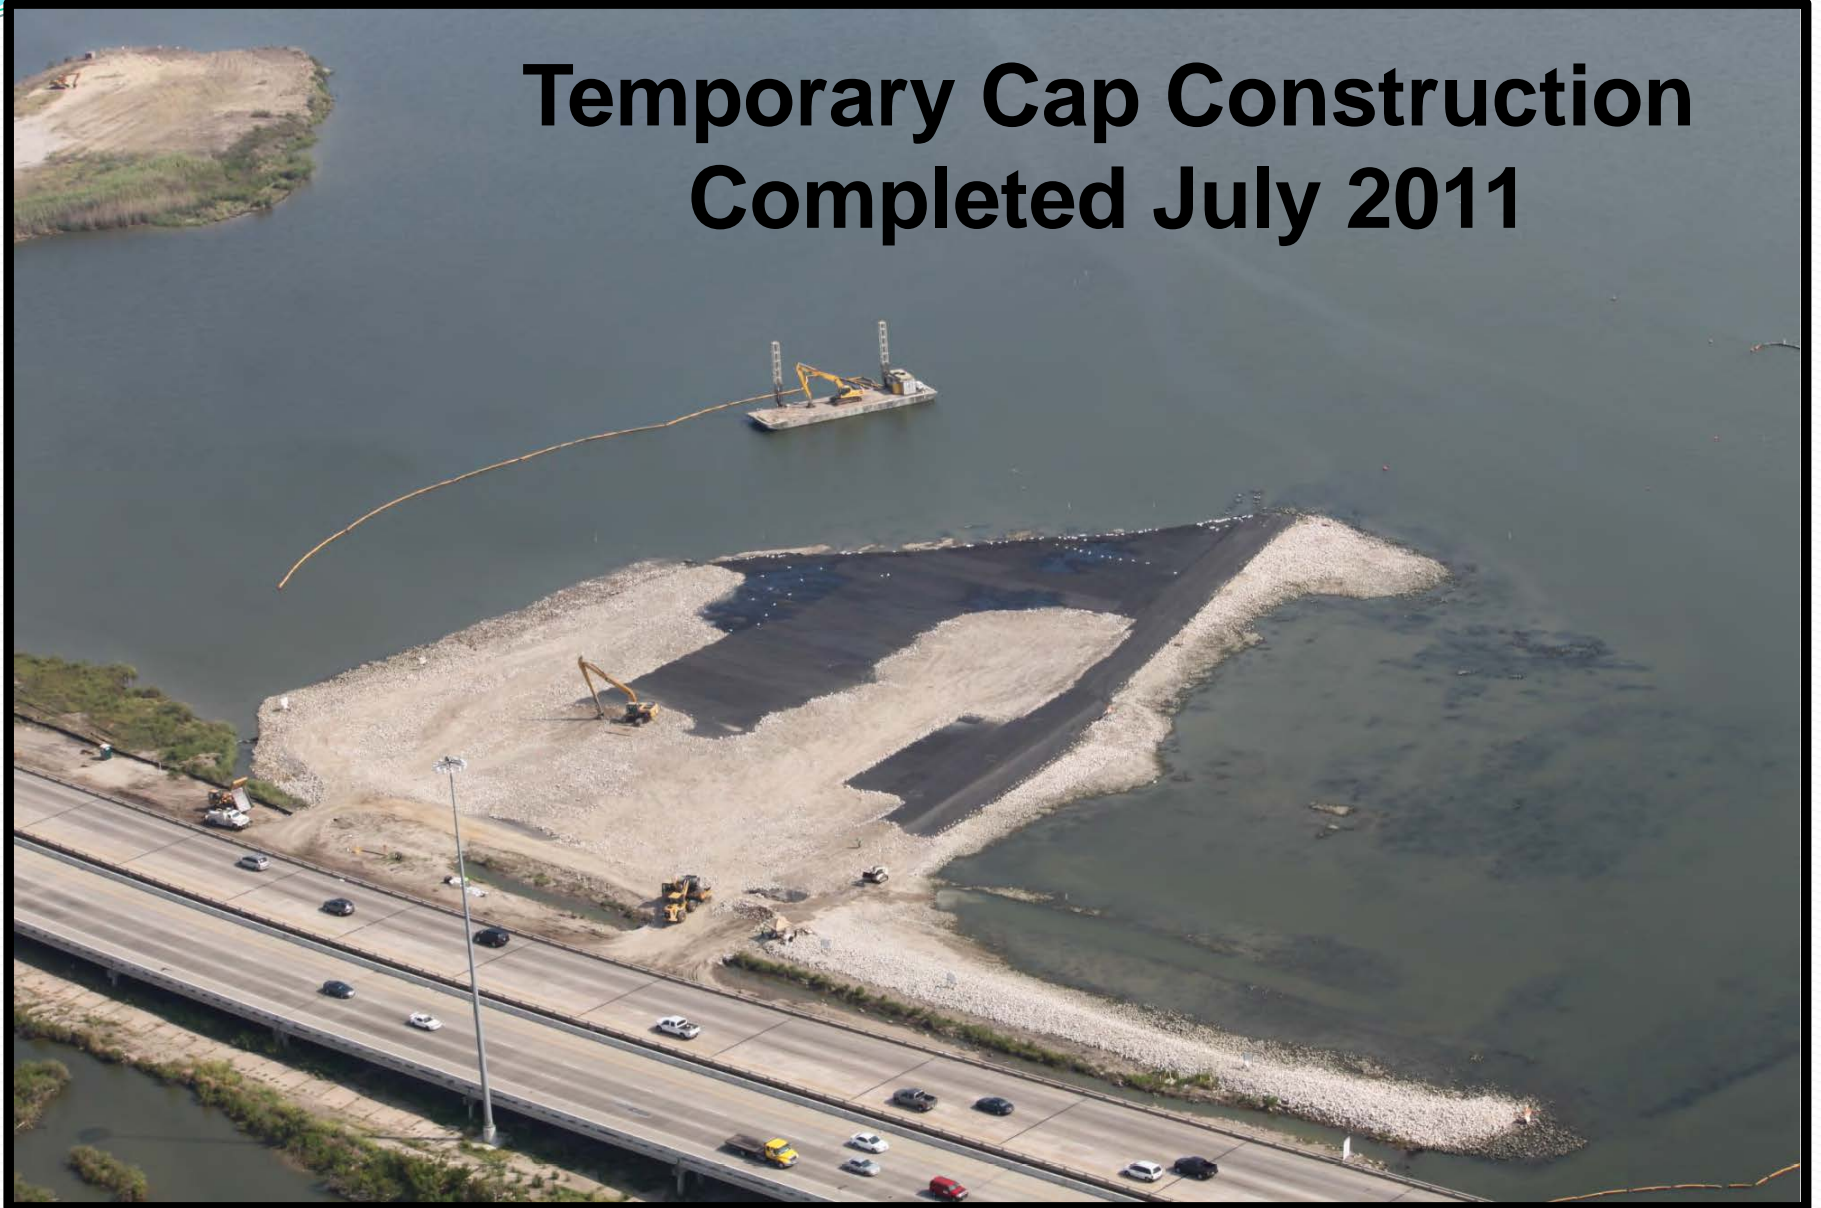
Temporary Cap Construction Completed July 2011

- **Review of PRP modeling report.**
- **Review of PRP temporary cap design.**
- **Review of PRP draft Feasibility Study.**
- **Special Permit Area (EPA/USACE/TCEQ).**

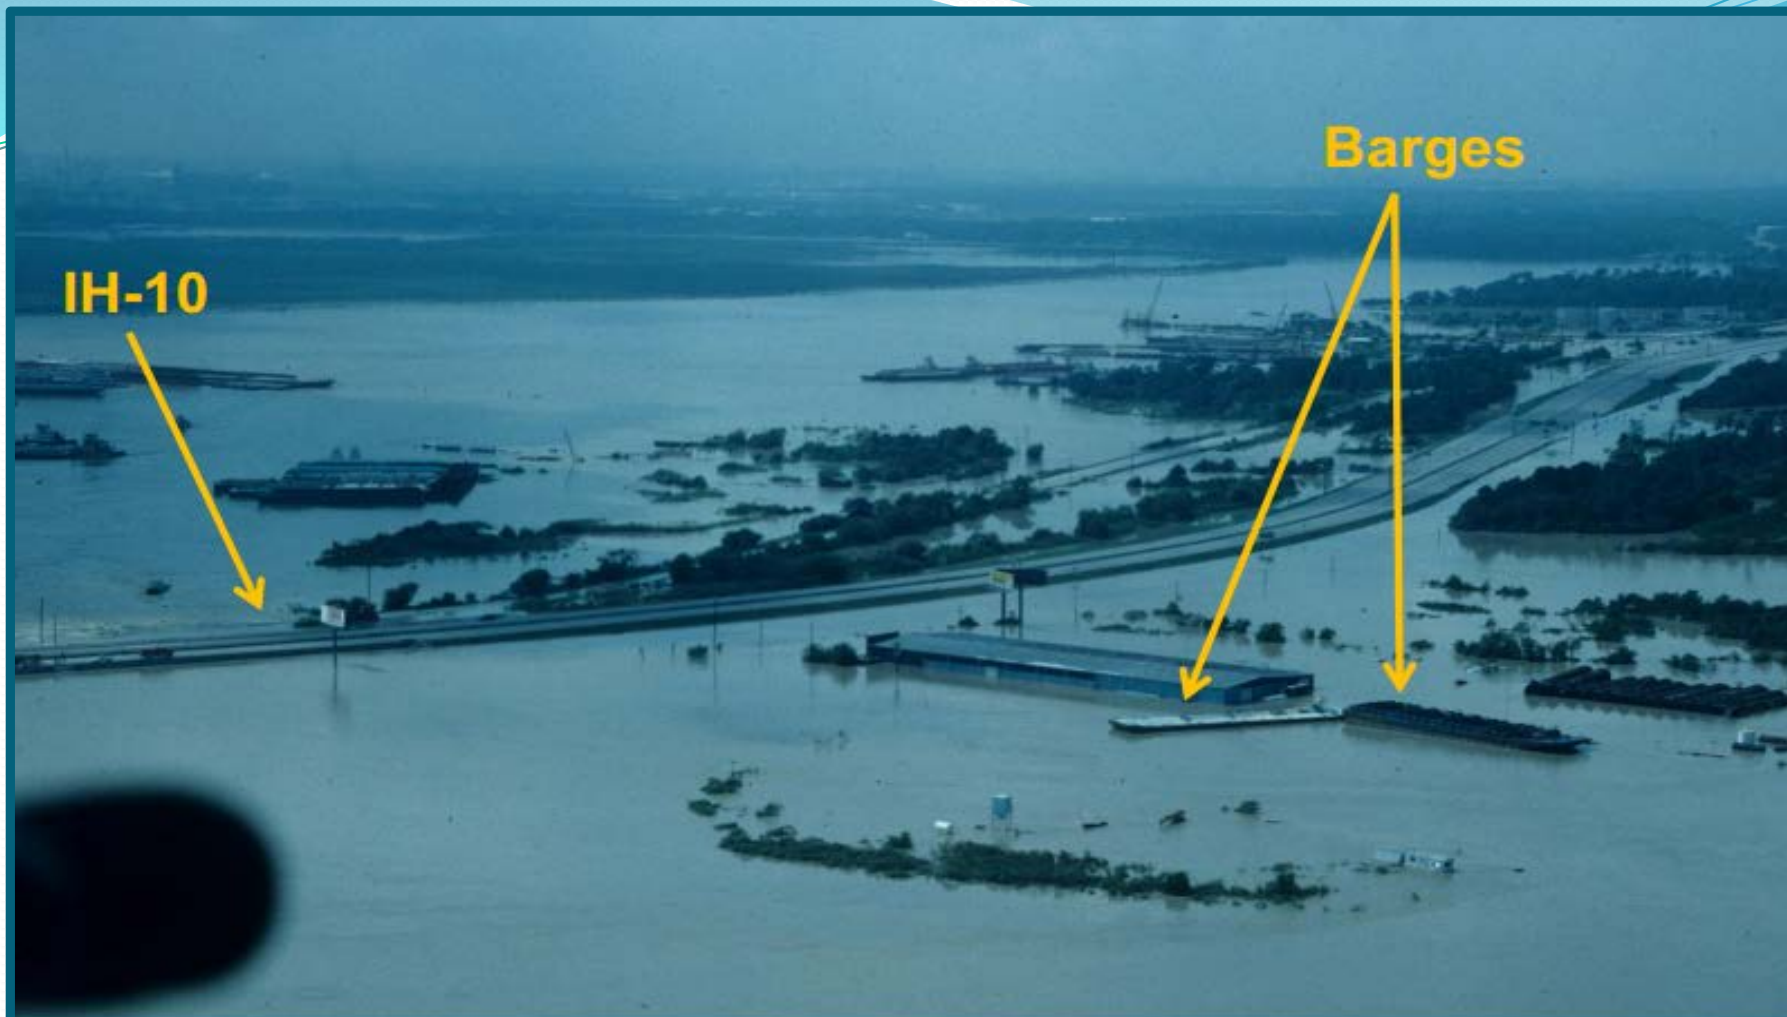
IH-10

Barges

Lower San Jacinto River

San Jacinto River at I-10 (Photo: HCFCD)

- Upper Texas coast recorded 25 hurricanes, 7 of which were major (Category 3 to 5) storms.
- October 1994 storm greater than 100-year flood (1.6 times):
 - Major soil erosion – 8 pipelines ruptured & 29 undermined; 3000 homes destroyed.
 - 10 to 12-feet of bed scour south of the I-10.

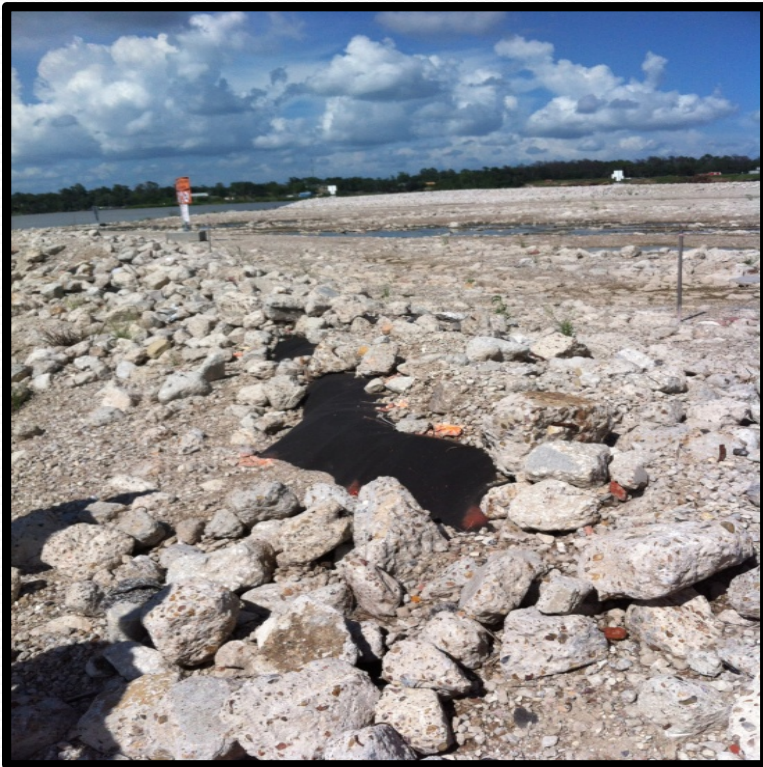
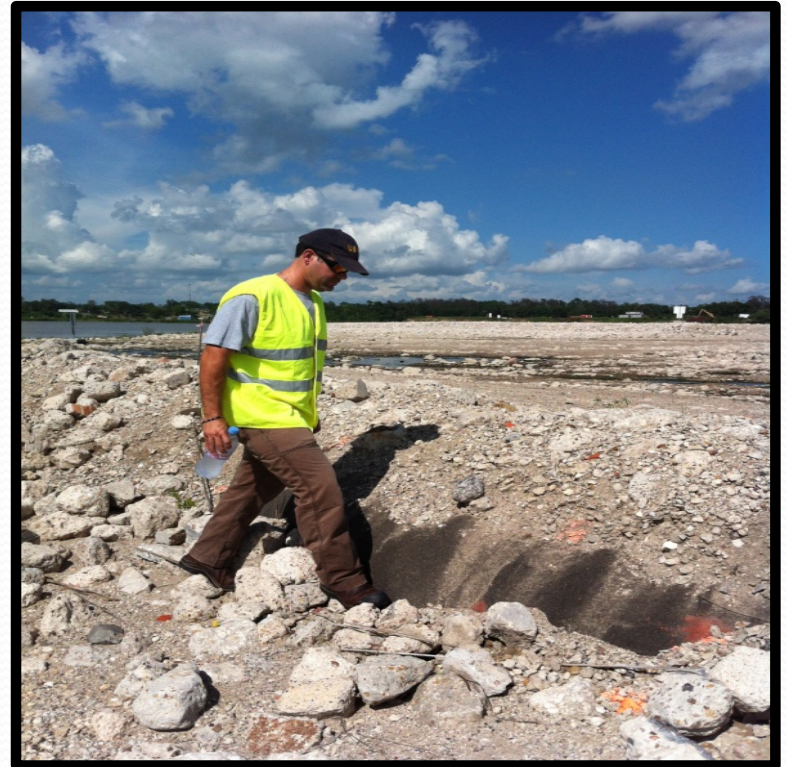
Temporary Cap – Berm Erosion

- Western Berm erosion July 2012.
- Completion of repairs August 2012.
